Failure Modes and Fracture Origins of Porcelain Veneers on Bilayer Dental Crowns

The aims of this study were to determine the fracture origins and crack paths in the porcelain of clinically failed bilayer ceramic restorations and to reveal the correlation between the porcelain failures and material properties. Three clinically failed crowns of each material (bilayer zirconia crowns, galvano-ceramic crowns, and porcelain-fused-to-metal crowns) were collected and underwent failure analysis. The fractures found in porcelain veneers showed several characteristics including wear, Hertzian cone crack, chipping off, and delamination. The results indicated that the fracture origins and features of the porcelain in bilayer ceramic restorations might be affected by the rigidity of core materials and thickness of copings. *Int J Prosthodont* 2014;27:147–150. doi: 10.11607/ijp.3608

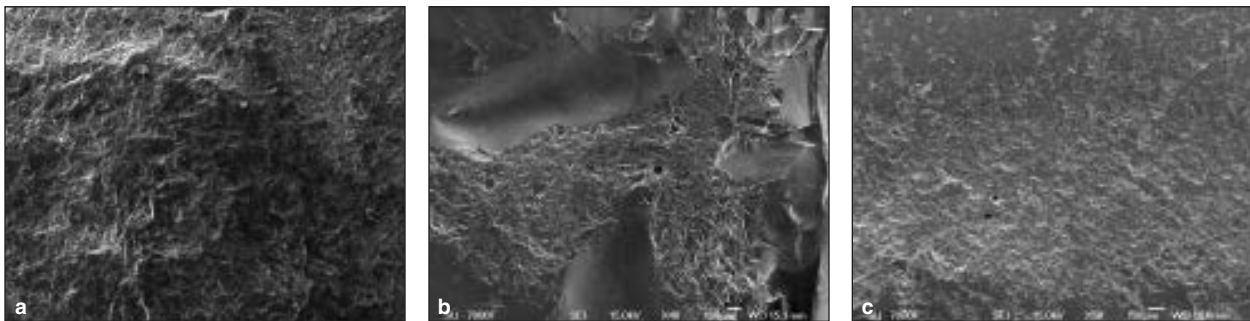
**Fig 1** Porcelain wear scars on the (a) occlusal surface of an Ni-Cr coping crown (mandibular molar), (b) occlusal surface of a zirconia crown (maxillary molar), and (c) lingual surface of a galvano-ceramic crown (maxillary incisor).

Several typical damage features were found in the porcelain. Wear scars were found on the surfaces of porcelain in all restorations, presenting as micro-cracks, roughness, and mass loss (Fig 1).

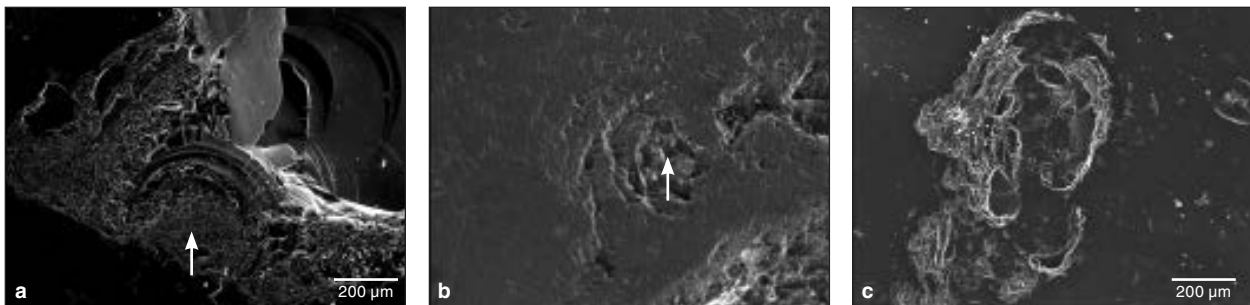
**Fig 2** Hertzian cone cracks observed in the porcelain: (a) typical Hertzian cone cracks observed on the occlusal surface of a maxillary molar zirconia crown and (b) the lingual surface of a maxillary incisor galvano-ceramic crown. The origins of the Hertzian cone cracks are marked by arrows. (c) The multiorigin cracks presented on the occlusal surface of a maxillary molar zirconia crown.

Hertzian cone cracks and multiorigin cracks were characteristic features visible on the occlusal surfaces of molar crowns and on the lingual surfaces of incisor crowns (Fig 2).

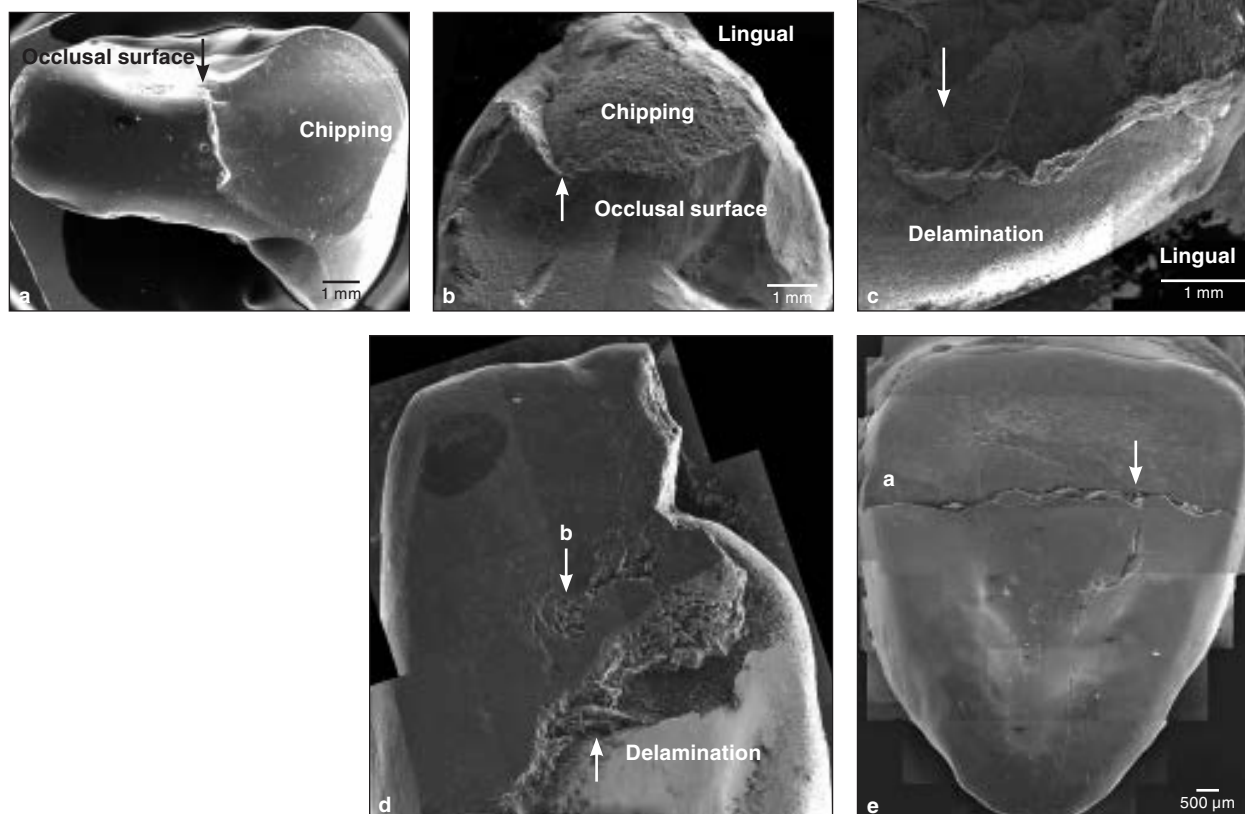
Fig 3 Fractography overviews by low magnification SEM micrographs of the failed bilayer ceramic crowns. **(a)** The porcelain chipping damage was observed on the occlusal surface of a maxillary molar zirconia crown. Arrow indicates the fracture origin of a Hertzian cone crack. **(b)** The lingual part of a maxillary premolar noble alloy porcelain-fused-to-metal crown was illustrated by merging 15 individual SEM images. Arrow indicates the origin of a Hertzian cone crack. **(c)** The distal part of the mandibular molar Ni-Cr alloy porcelain-fused-to-metal crown was shown by merging 20 SEM images. The fracture origin was marked with an arrow. **(d)** The lingual side of a maxillary incisor galvano-ceramic crown was illustrated by merging 13 SEM images. The fracture origin was marked by arrow "a," and a Hertzian cone crack was marked by arrow "b." **(e)** The lingual side of a maxillary incisor galvano-ceramic crown was illustrated by merging 30 SEM images. The porcelain chipping was marked by "a," and porcelain fracture was marked by an arrow.

and zirconia. Figure 3a shows the fractured surface of a maxillary molar zirconia crown after porcelain chipping off. The fracture was initiated by Hertzian cone crack at the distal marginal ridge on the occlusal surface. As seen in Fig 3b, Hertzian cone crack yielded the porcelain chipping on the occlusal surface of a premolar noble metal alloy crown.

Porcelain delaminations originating at the occlusal contact were observed on noble metal alloy porcelain-fused-to-metal and zirconia crowns. As shown in Fig 3c, the porcelain delaminations originated from multiorigin cracks on the occlusal surface of a mandibular molar Ni-Cr coping crown.

In contrast, the porcelain delaminations on the galvano crowns originated from the porcelain-core interface. The clear arrest lines on the fracture surface of a maxillary incisor galvano crown indicated that the porcelain fracture originated from the porcelain-core interface (Fig 3d). High magnification observation revealed that the microcracks were only detected at the porcelain-core interface (Fig 4a). The same fracture origin and crack path were also found in another incisor galvano crown (Fig 3e). The arrest lines occurred on the concave side toward the core-porcelain interface (Fig 4b). Additionally, wake hackles were observed on the side away from the inner core (Fig 4c).

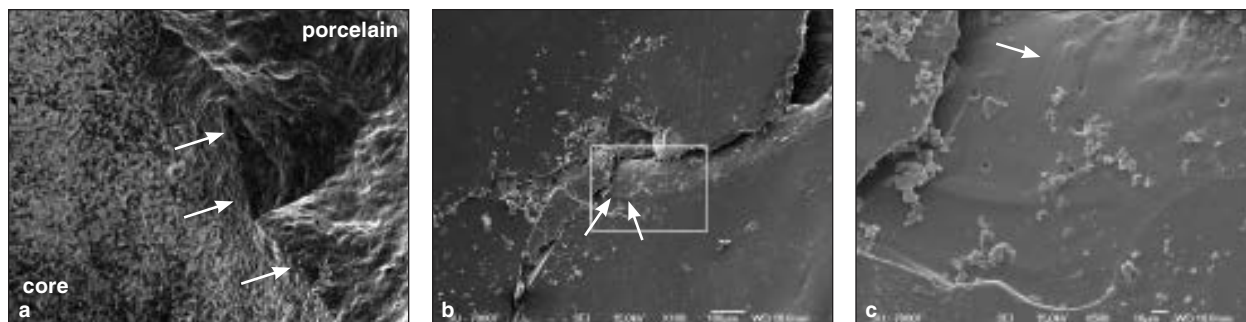
Fig 4 Fracture surfaces of galvano-ceramic crowns revealing interface fracture origins. **(a)** The critical cracks at the porcelain-core interface are marked by arrows in a maxillary incisor crown. **(b)** The arrest lines occurred on the concave side toward the core-porcelain interface in the fracture area of a maxillary incisor crown. **(c)** The wake hackles (*arrow*) were observed on the side away from the inner core.

These features indicated that the porcelain fracture might have initiated at the core-porcelain interface.

Microcracks at the porcelain-core interface were observed only in the galvano crowns. The formation of microcracks was initiated by the momentarily high tensile stress due to plastic deformation of galvano-gold copings, which relate to poor rigidity and strength, but add only 0.3 to 0.4 mm of thickness.
